# Manhole Inspection Summary

Manhole # S29YY\_035MH

Insp Date: **5/22/07 10:28 AM**

**Location** Address: **522 BEECHE AVE**

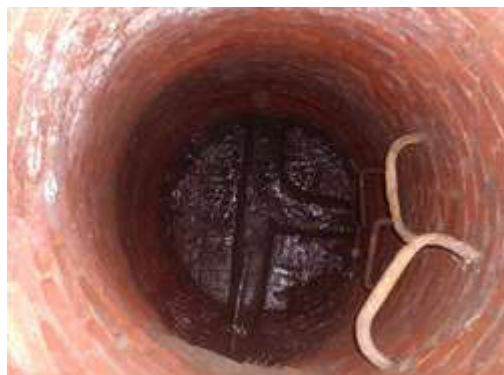
Top View

Corroded steps. Bench debris.

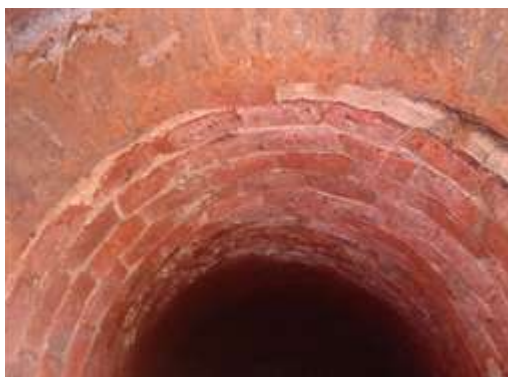
Defect

Frame leaks. Adjustment deterioration, loose brick, root intrusion and infiltration. Corbel infiltration.

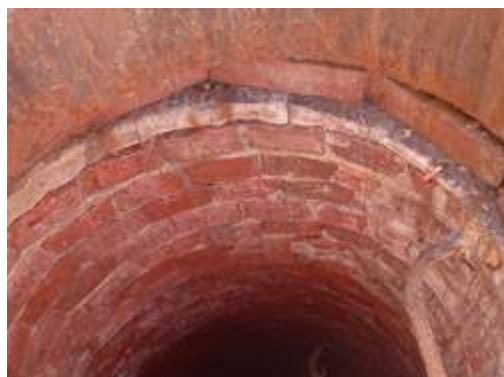
Defect

Frame leaks. Adjustment deterioration, loose brick, root intrusion and infiltration. Corbel deterioration and infiltration.

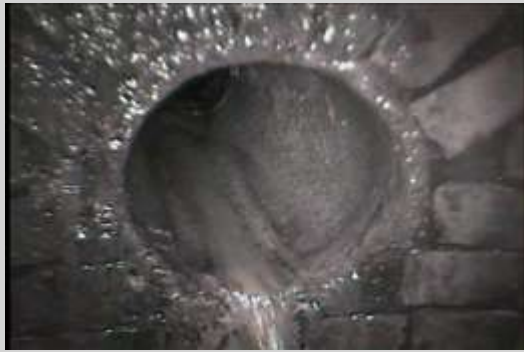
### 8 in. Circular Gravity Sewer

Infiltration: **Evidence** Pipe Seal Cond: **Roots**

Drop: **Outside** Rod and Bar  
Angled: **Yes** Reading: **12.93** (ft.)  
Inv Depth: **13.93** (ft.)  
Drop Condition: **Partly Clogged**

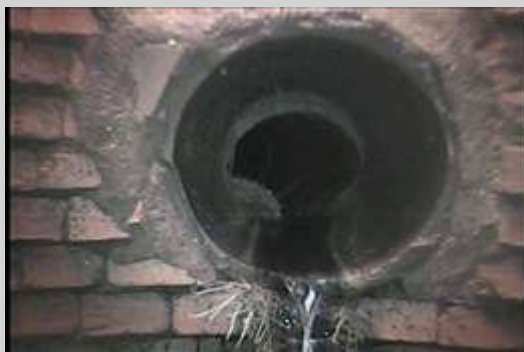
### 10 in. Circular Gravity Sewer

Infiltration: **Evidence** Pipe Seal Cond: **Roots**
